WYLE LABS HUNTSVILLE ALA  
CAPSIZING/SWAMPING ACCIDENT INVESTIGATIONS FOR 1976 SEASON. (U)  
SEP 77 J BOWMAN, B SMITH

CAPSIZING/SWAMPING ACCIDENT INVESTIGATIONS FOR 1976 SEASON

16. Abstract From several hundred boating accidents, 28 were selected for in-depth investigations. These in-depth investigations were performed to augment and supplement the Coast Guard's data base acquired from the nationwide Boating Accident Reports (BARs). Unlike the several thousand BARs received annually, the in-depths contain details of the entire accident scenario and are used to assist in establishing national programs of loading related accident prevention by boat design and education.  This report summarizes the criteria for selection of those accidents to be investigated, the investigation procedures, and the accident data obtained for the 28 in-depth investigations. Each individual accident report is presented as Appendices to the summary report. The accident reports present information concerning the weather, the involved boat and occupants, causal factors, boat capacities and loading/powering information, and occupant actions/reactions prior to, during, and after the actual accident event.

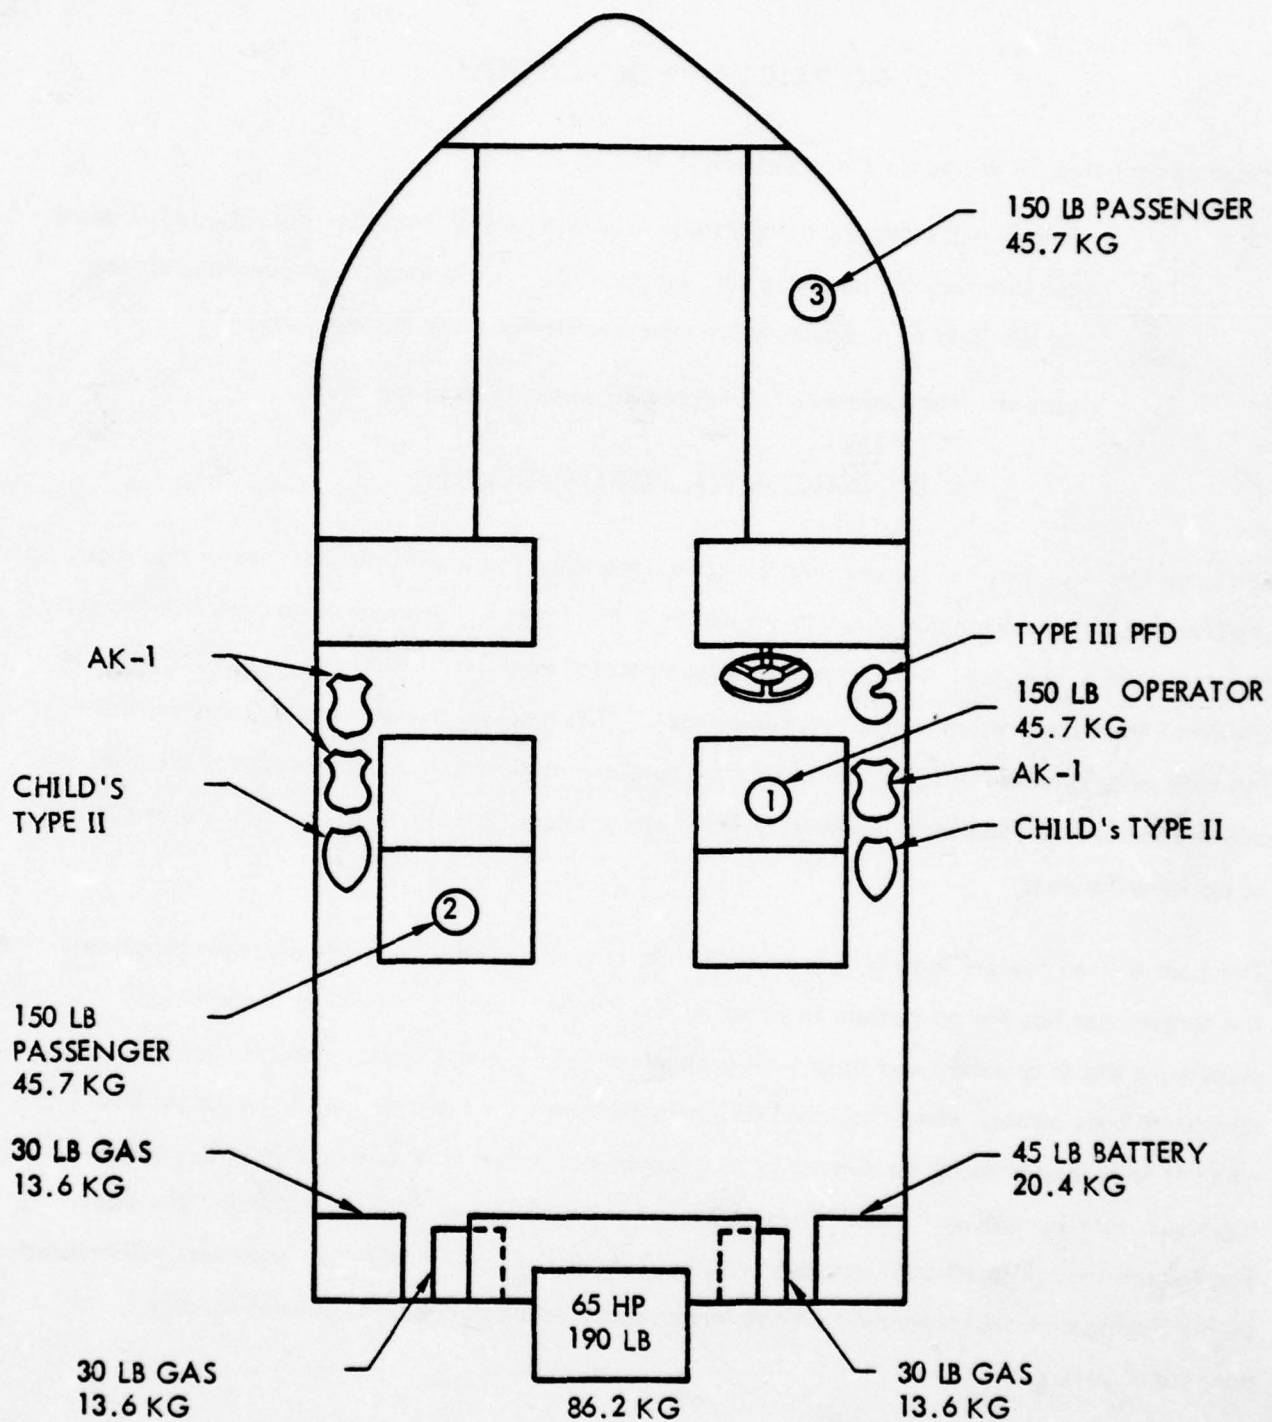
FIGURE 1. LOAD DISTRIBUTION

Although the boat was not loaded over its capacity plate figure with persons, motor and gear, it quite probably contained a quantity of water in the inner hull enough to exceed the capacity and reduce the freeboard. The inexperienced operator could very likely fail to recognize the impaired handling present in such circumstances. (The amount of water in the inner hull at the time of the accident could have been substantial: the present owner had never checked it, and the last owner reportedly knew very little about boats, having received this one as part of an inheritance.)

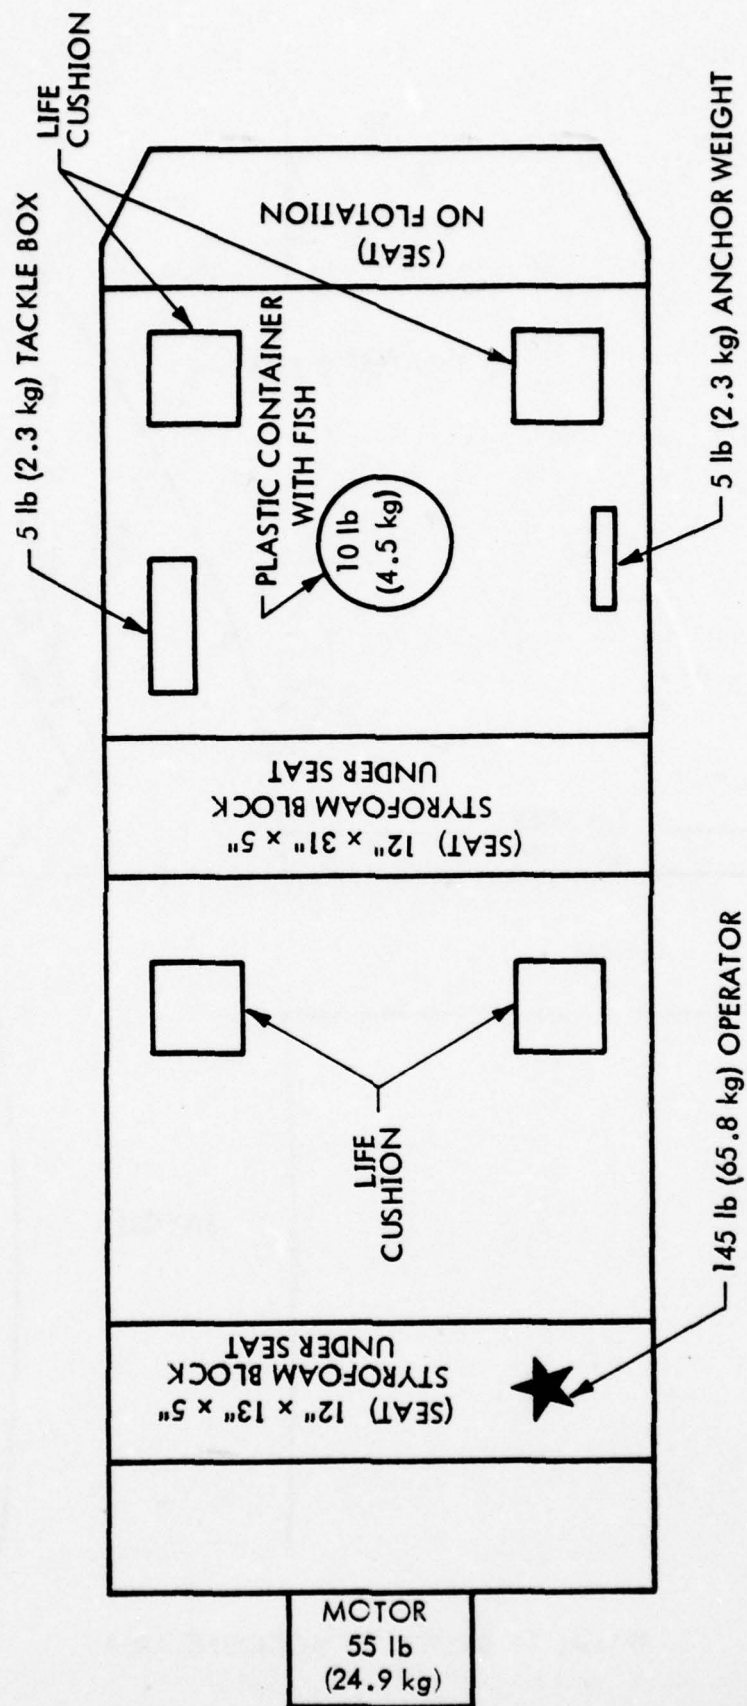
FIGURE 1. BOAT LOAD DISTRIBUTION AT TIME OF ACCIDENT

According to the estimated weight in the boat at the time of the accident, the boat was not overloaded. However, considering the operator's weight at the starboard stern (normal operating position), the boat would have a tendency to roll to starboard when disturbed about the longitudinal axis. The intercept angle of the boat with the stern wake caused the port bow to impact the wave first. As the bow rode up on the wave, the boat rolled to starboard, causing the weight of the operator to be shifted further starboard in relation to the vertical centerline of the boat. Also, as the bow went up the operator's weight was shifted aft in relation to the lateral axis of the boat, which caused the transom freeboard to decrease to a point that water flowed freely over the starboard stern. The sudden roll and pitch of the boat caused the center of gravity of the operator to shift aft and starboard sufficiently to cause him to be thrown overboard. After the operator was thrown out, the boat had taken on enough water to decrease the transom freeboard to zero, which allowed the boat to flood. The flotation material under the seats kept the boat upright and prevented it from completely sinking.

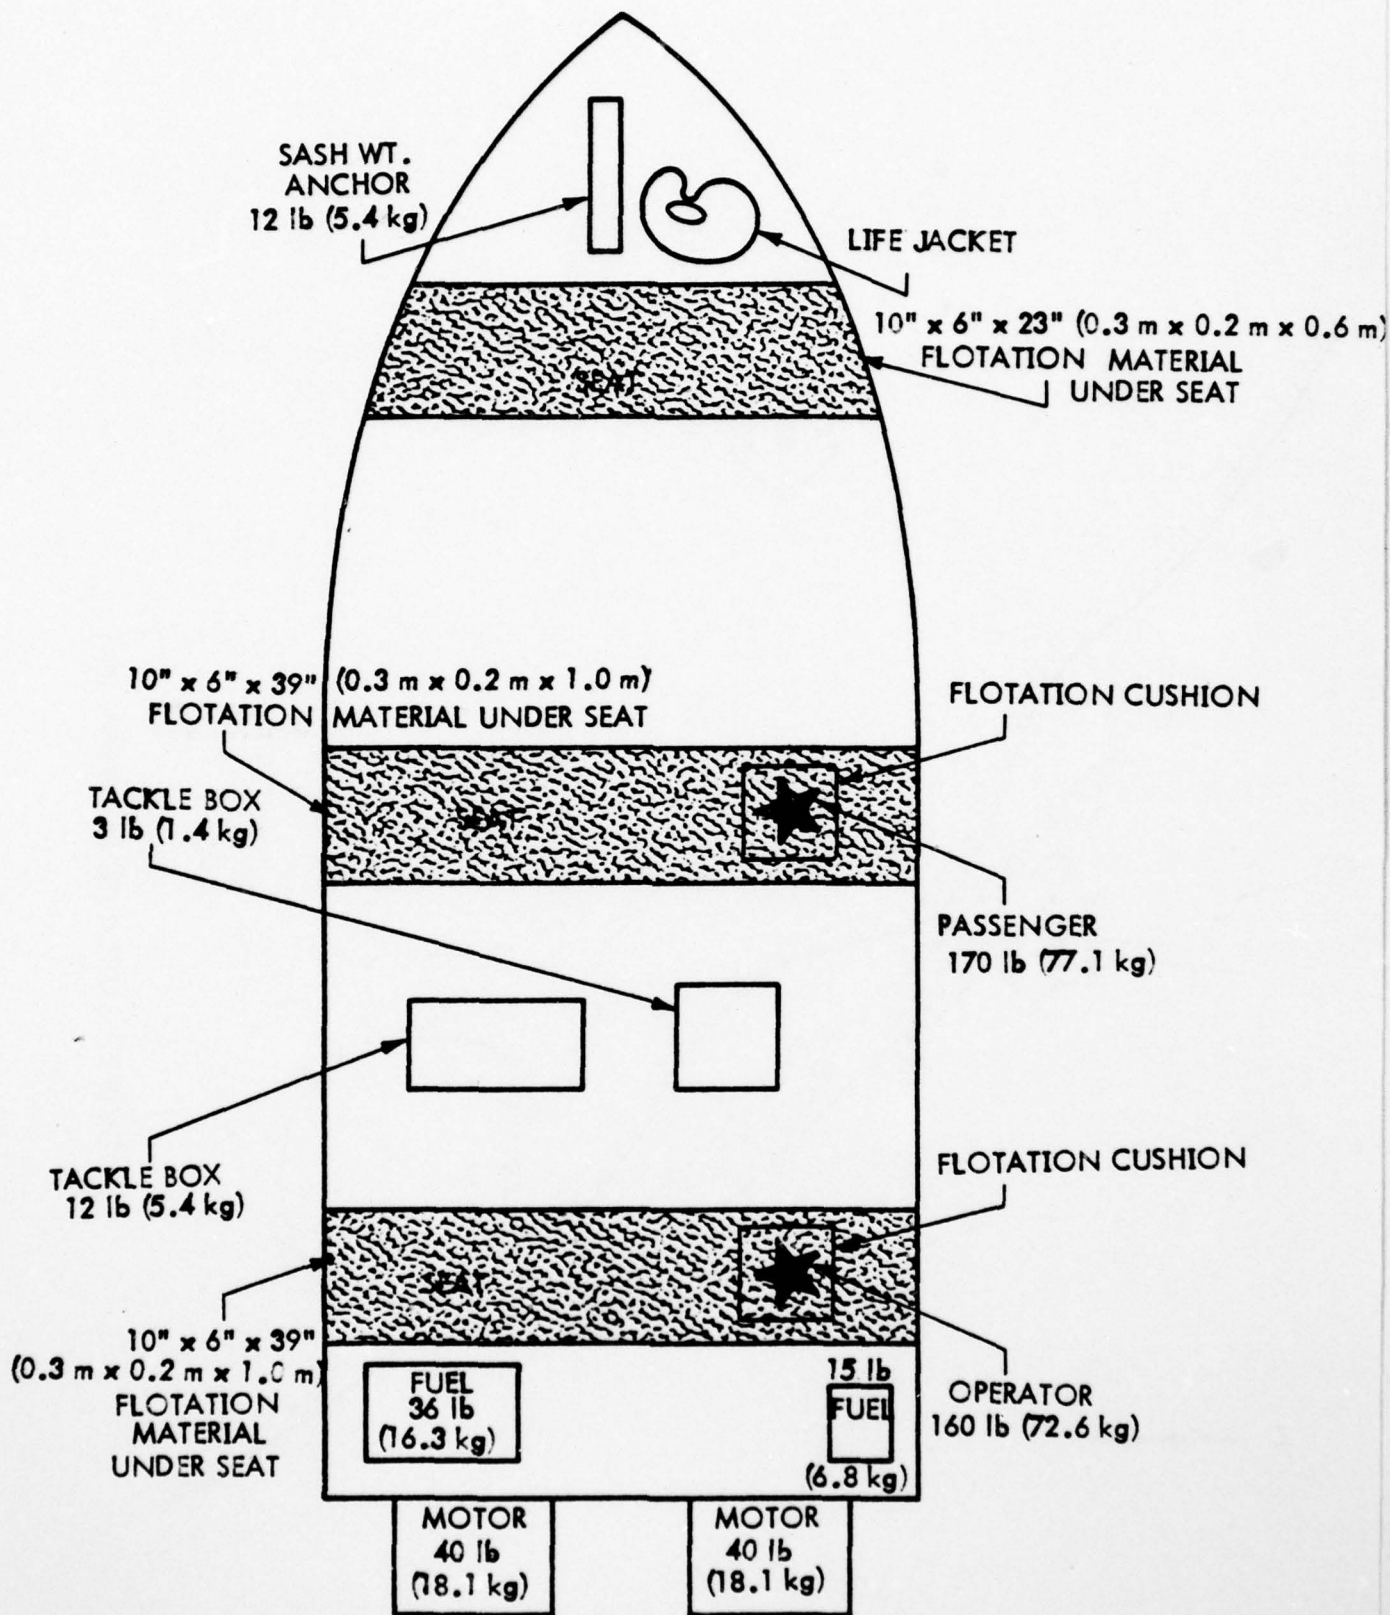
FIGURE 2. BOAT LOAD DISTRIBUTION AT TIME OF ACCIDENT

Both occupants were seated on the starboard side which would cause the boat to list to starboard. When the operator stood, effectively, the vertical center of gravity of the boat was raised, which lowered the transverse stability. The dynamic effect of the operator falling into the passenger initiated a sufficient roll moment to cause the boat to capsize and the occupants to fall overboard.

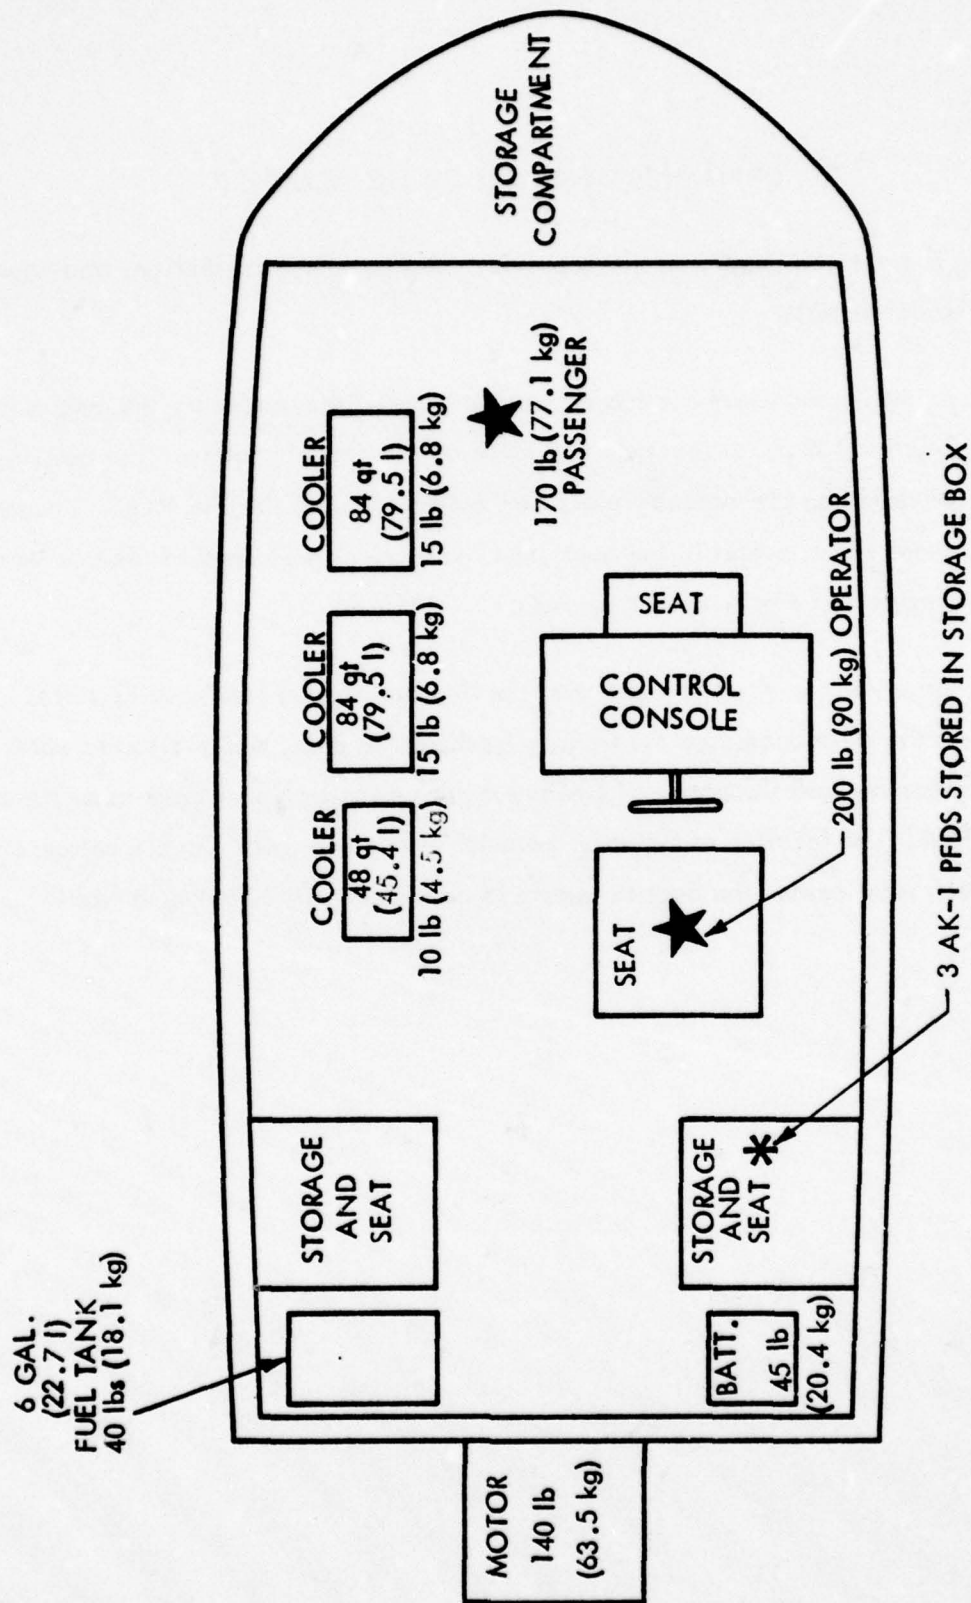
FIGURE 1. LOAD DISTRIBUTION AT TIME OF ACCIDENT

According to the estimated weight in the boat at the time of the accident, the maximum weight capacity was 240 lbs (108.9 kg) less than the value on the capacity plate. The maximum persons capacity as stated on the capacity plate was exceeded by 45 lbs (20.4 kg). According to the operator, there was no water in the boat until the vertical movement of the bow was restricted and waves started breaking over the bow.

Apparently a large volume of water came over the bow and flowed freely to the stern. The water weight in the stern decreased the transom freeboard to zero, which allowed water to flow over the transom into the boat. The heavy motor on the transom would cause the boat to sink stern first. The location of flotation material in this type boat (double bottom and halfway up each side) caused the boat to remain in an upright attitude after it was swamped.

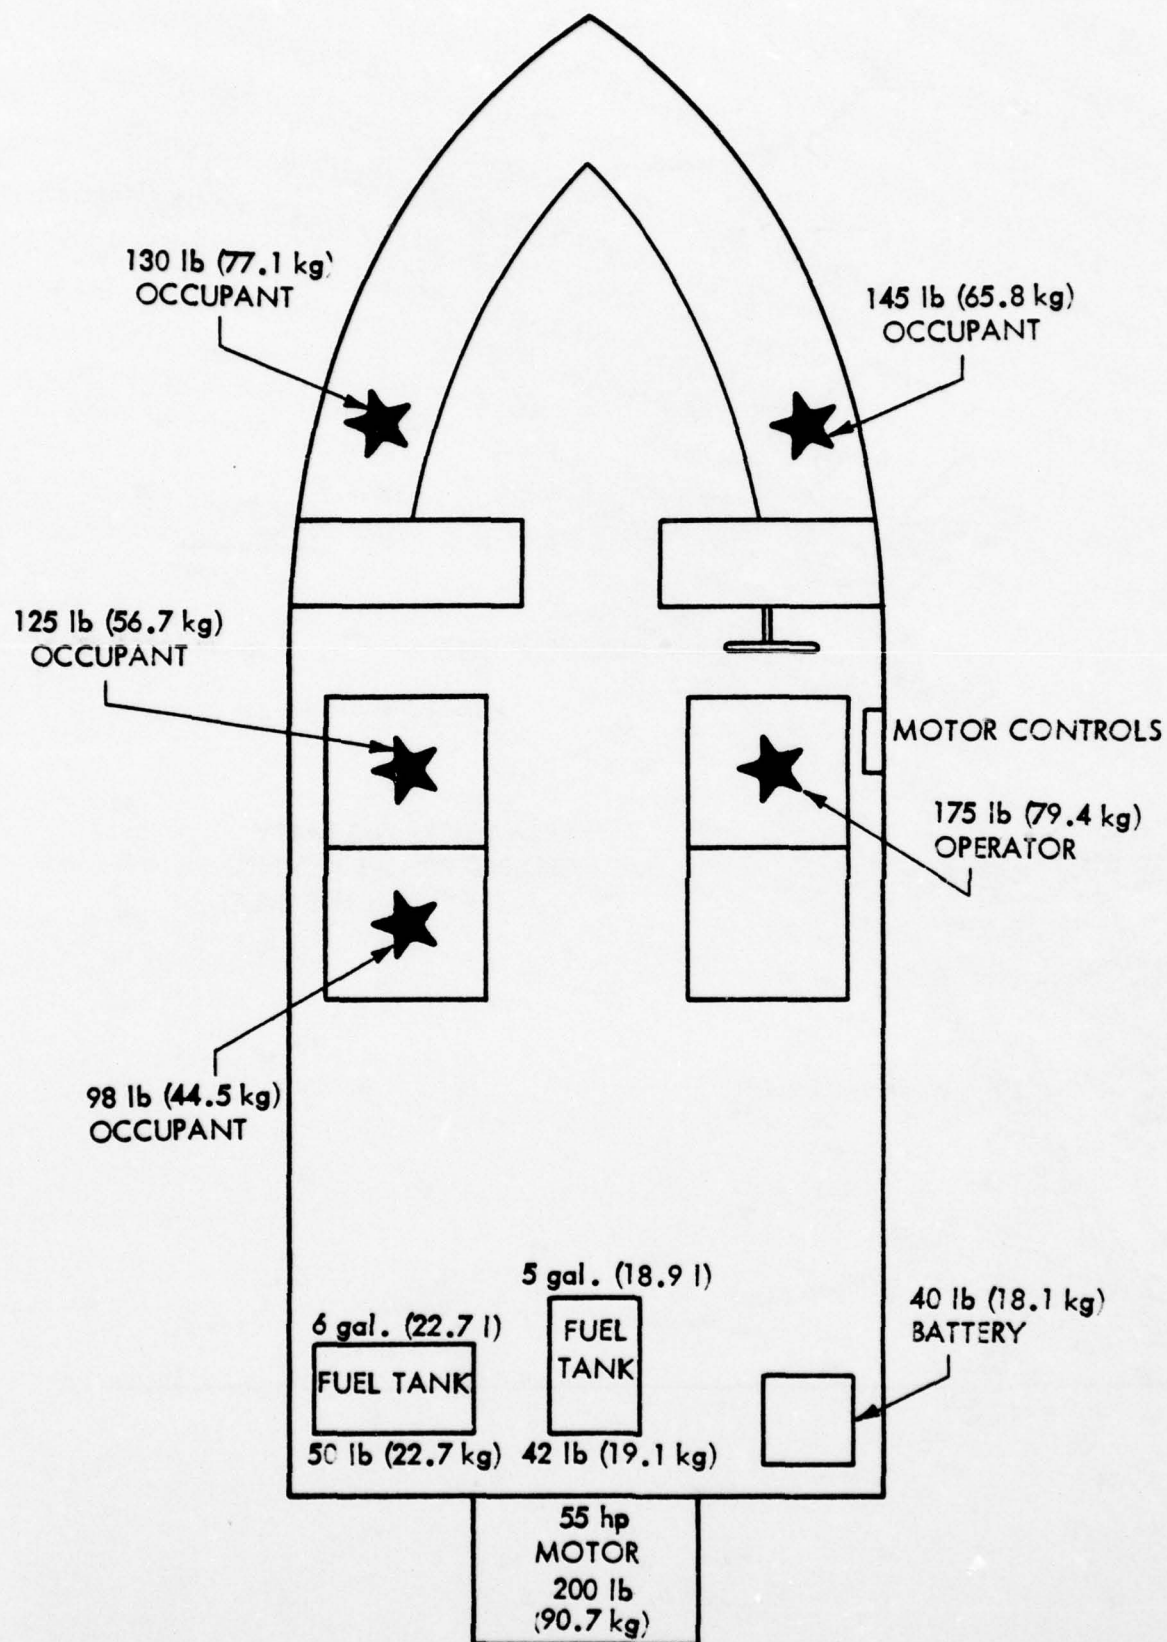
FIGURE 1. BOAT LOADING CONFIGURATION  
G-9

The occupants of the boat, wanting to "keep the boat in one place near the operator," shut the boat off. They were not aware that the oncoming waves and light wind would carry them into the breaking surf and onto the beach. At the time, however, this appeared to be the best thing to do, since no one in the boat knew how to operate it. The boat drifted into the breaking surf, allowing the breaking waves to break over the transom and swamp the boat.

Attempting to negotiate the breaking surf in a boat which had free water remaining in it from the first swamping was not a wise thing to do. The water shorted out the battery, causing the engine to stop, and thus allowing the oncoming waves to once again break into the boat, filling it with water.

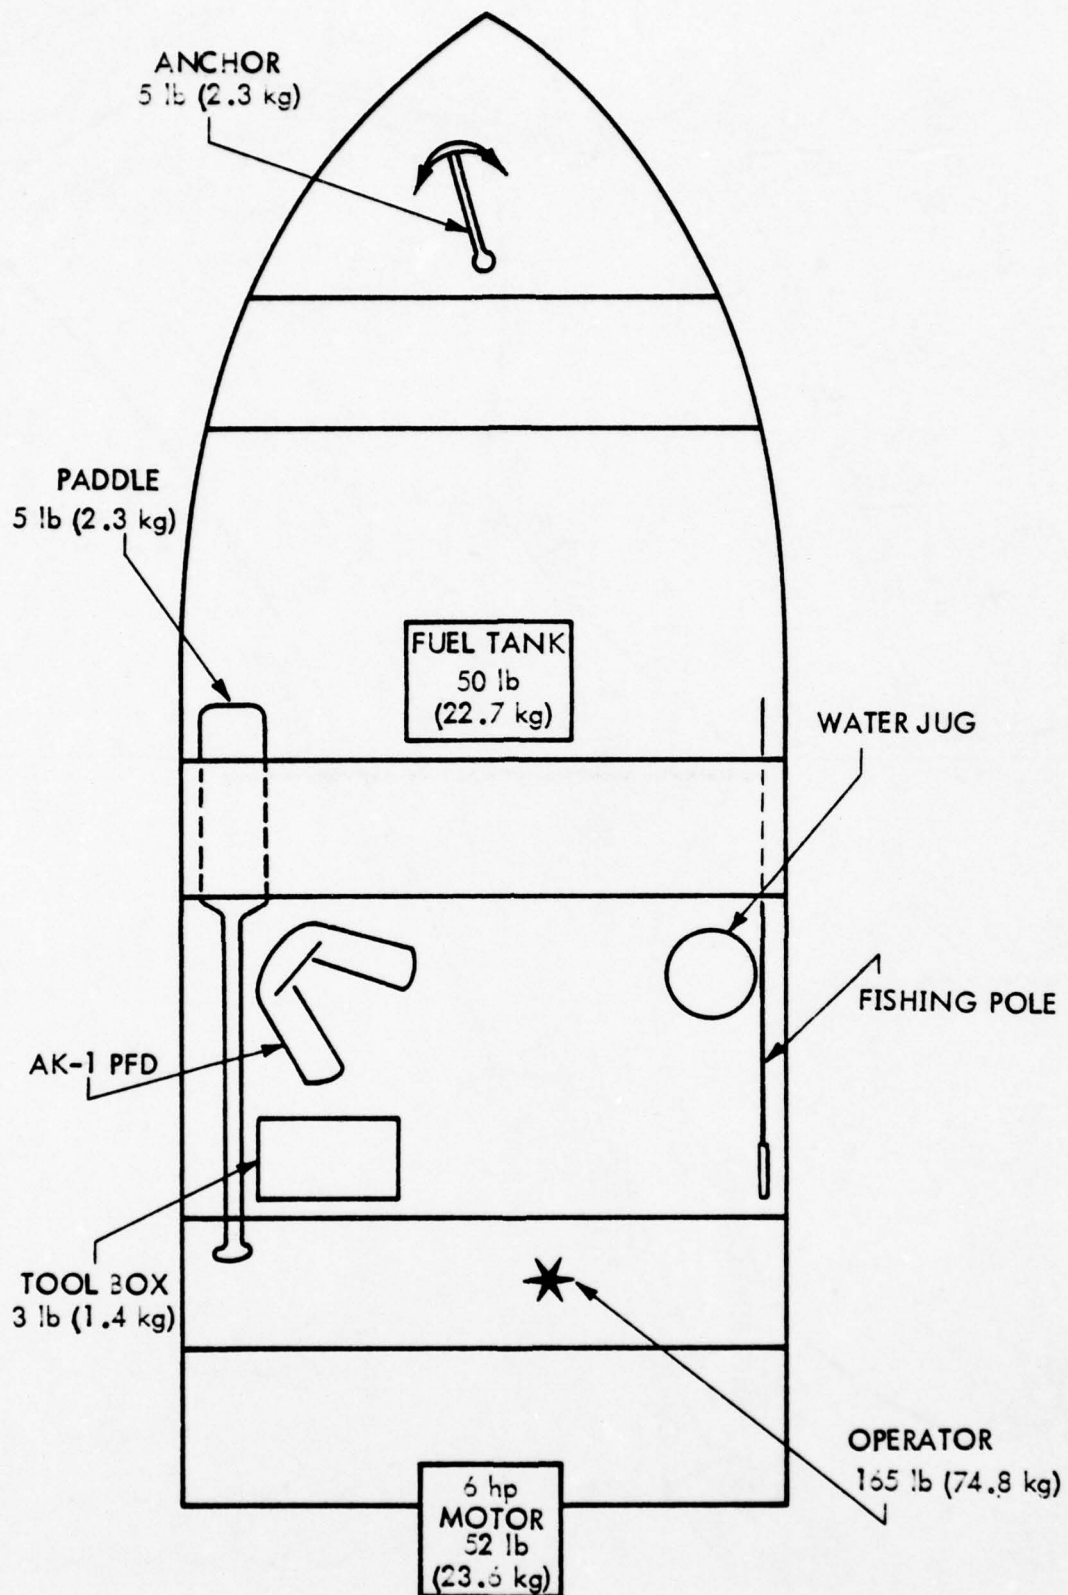
FIGURE 2. WEIGHT DISTRIBUTION PRIOR TO ACCIDENT

The load in the boat was less than the maximum allowable capacity displayed on the capacity plate. Improper load placement could have contributed to the capsize. The operator was sitting slightly to starboard of centerline while operating the boat with his left hand. Successive waves hitting the boat broadside could have caused the fuel tank to shift to starboard, increasing the heeling moment to starboard. A breaking wave hitting the boat broadside, on the high side could have relatively easily caused the load to shift further, causing the boat to capsize. Even if the load had been distributed about the centerline so there was no heeling moment, a breaking wave hitting a boat of this size broadside could have relatively easily caused it to capsize.

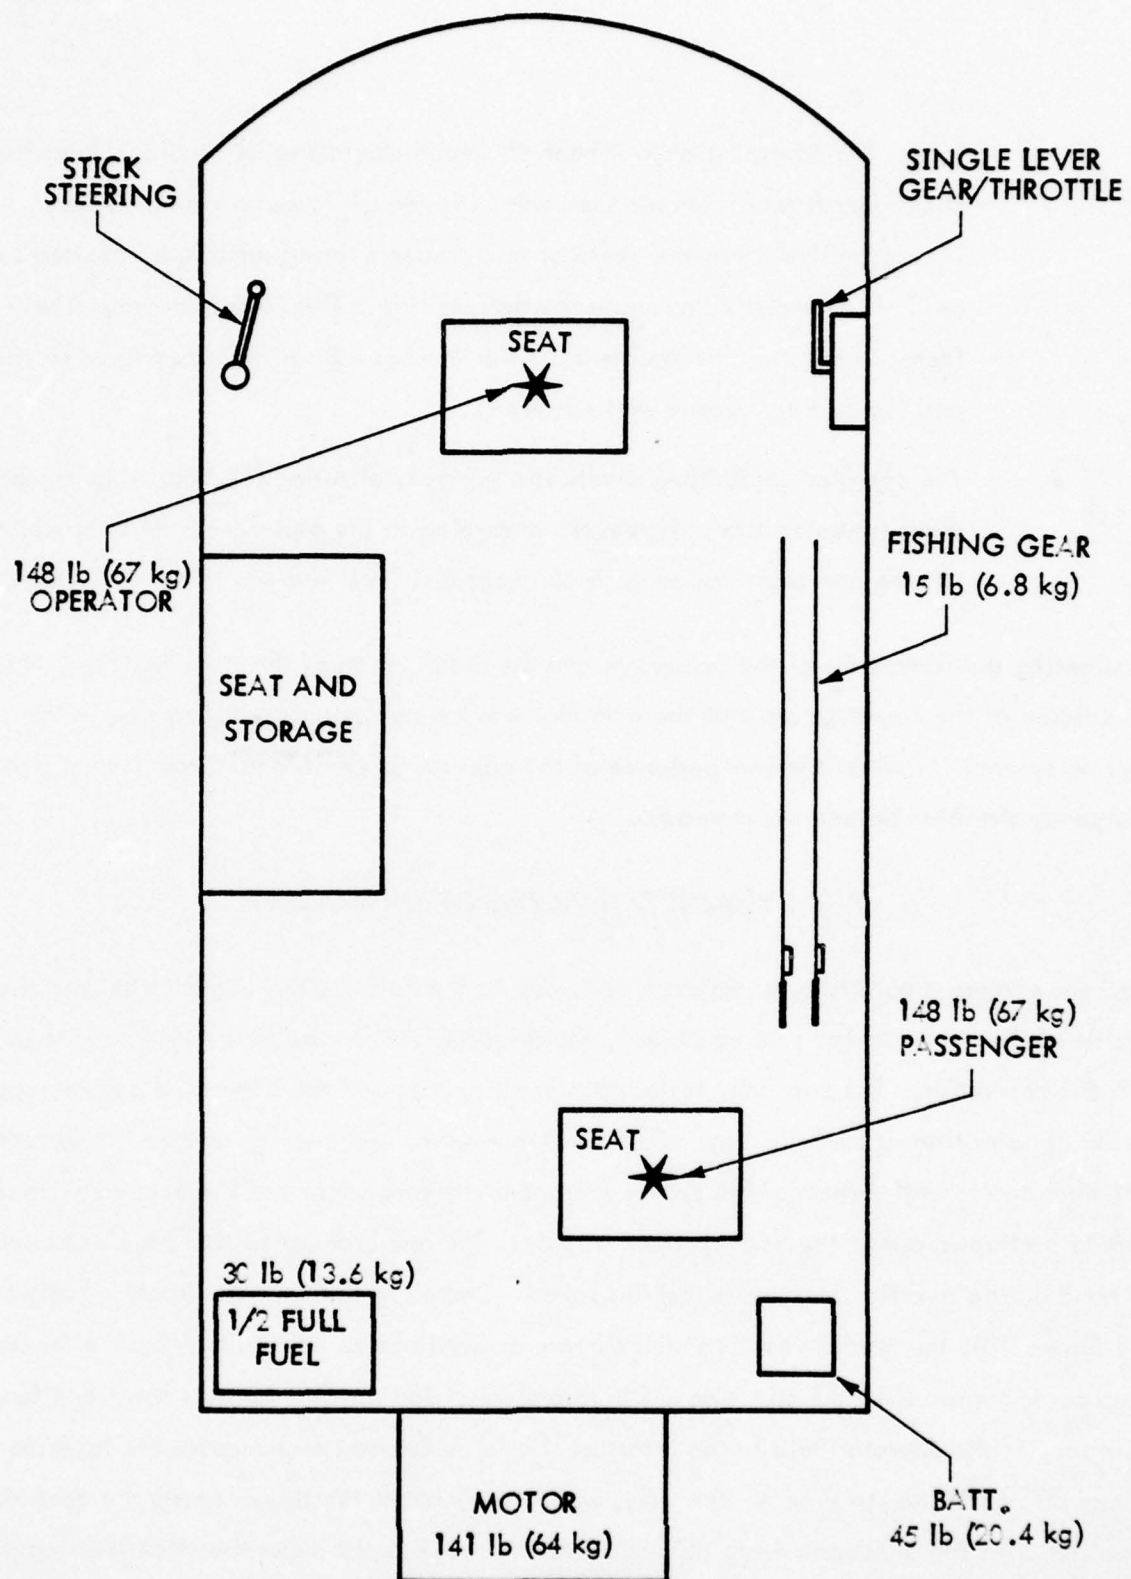
FIGURE 1. BOAT LOAD DISTRIBUTION AT TIME OF ACCIDENT

The boat entered a hard turn to starboard and, due to the hull design, began to skid to the outside of the turn. As the turn continued, the skidding action caused the keel to ride up over the bow wake. The boat then rolled to port (tripped), and the port chine dug in, causing the skidding motion to abruptly stop. Sufficient momentum had been generated in the turn, so that when the lateral motion of the boat was stopped, the momentum of the occupants caused them to be thrown out of the boat on the port side. The operator stated that he always kept his hand on the throttle when traveling full speed. Seated in the normal operating position (see Figure 10), the normal reaction of the operator would be to hold to the throttle for support when being thrown over the port side. The throttle position for full speed is down and forward; therefore, if the operator held to the throttle, the force exerted would cause the lever to come up and aft, reducing the engine rpm. This would account for the slower speed the boat was traveling after the occupants were thrown overboard. Figure 10 shows the stick steering position for zero motor angle after the accident. Figure 11 shows the approximate normal zero motor angle position prior to the accident.

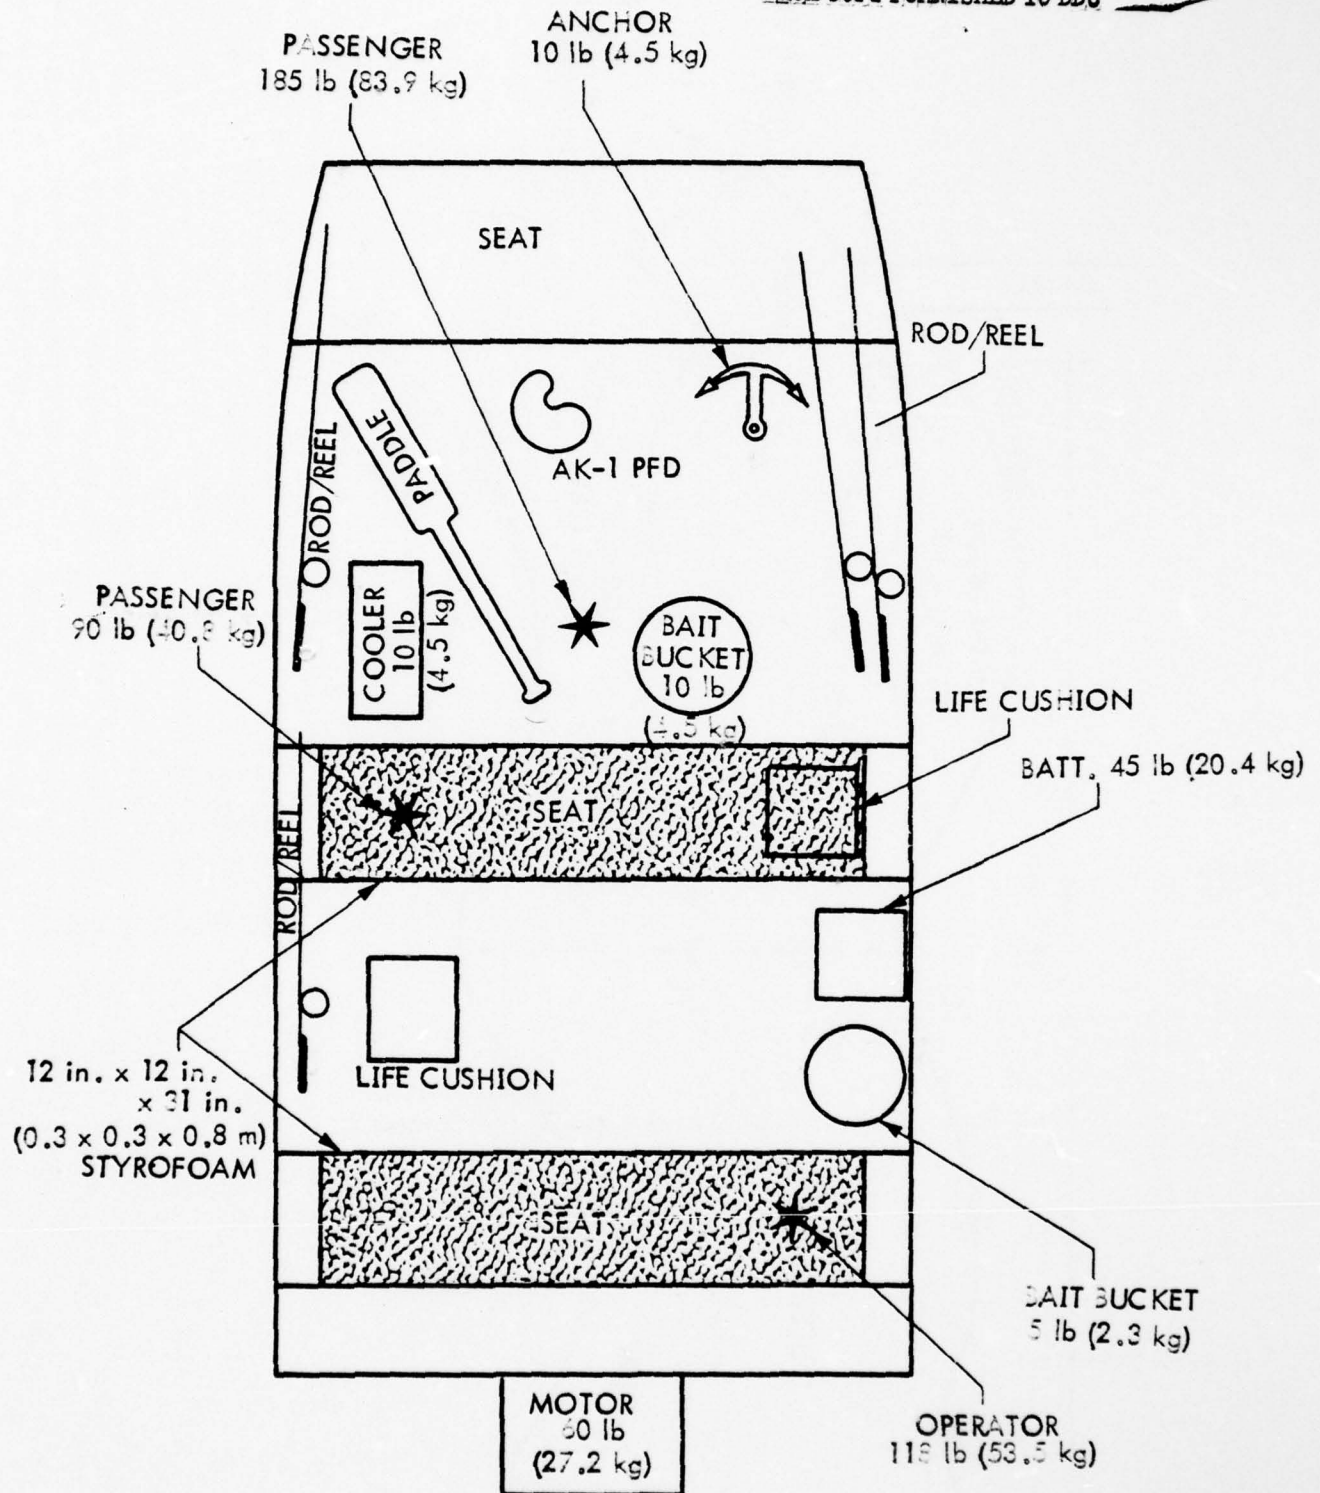
FIGURE 1. LOAD DISTRIBUTION AT TIME OF ACCIDENT

According to the estimated weight in the boat at the time of the accident, the boat was not overloaded. The load distribution was such that the boat was most likely running essentially in a level attitude at idle speed. When the boat rode up over the wave, the bow dropped into the valley with sufficient force to reduce the bow freeboard to near zero. The forward momentum of the boat then carried the bow into the next wave. The reduced bow freeboard allowed water to flow freely over the bow, completely swamping the boat. With the flotation material installed low in the boat and the center of gravity of the weight in the boat at a much higher level, the boat had a natural tendency to capsize when flooded. Passenger (2) stepped on the port gunwale when jumping out of the boat. His weight produced a sufficient roll moment to capsize the boat. After the boat was upside-down, the flotation material provided sufficient buoyancy to keep the boat afloat with (1) and (2) holding to the sides.

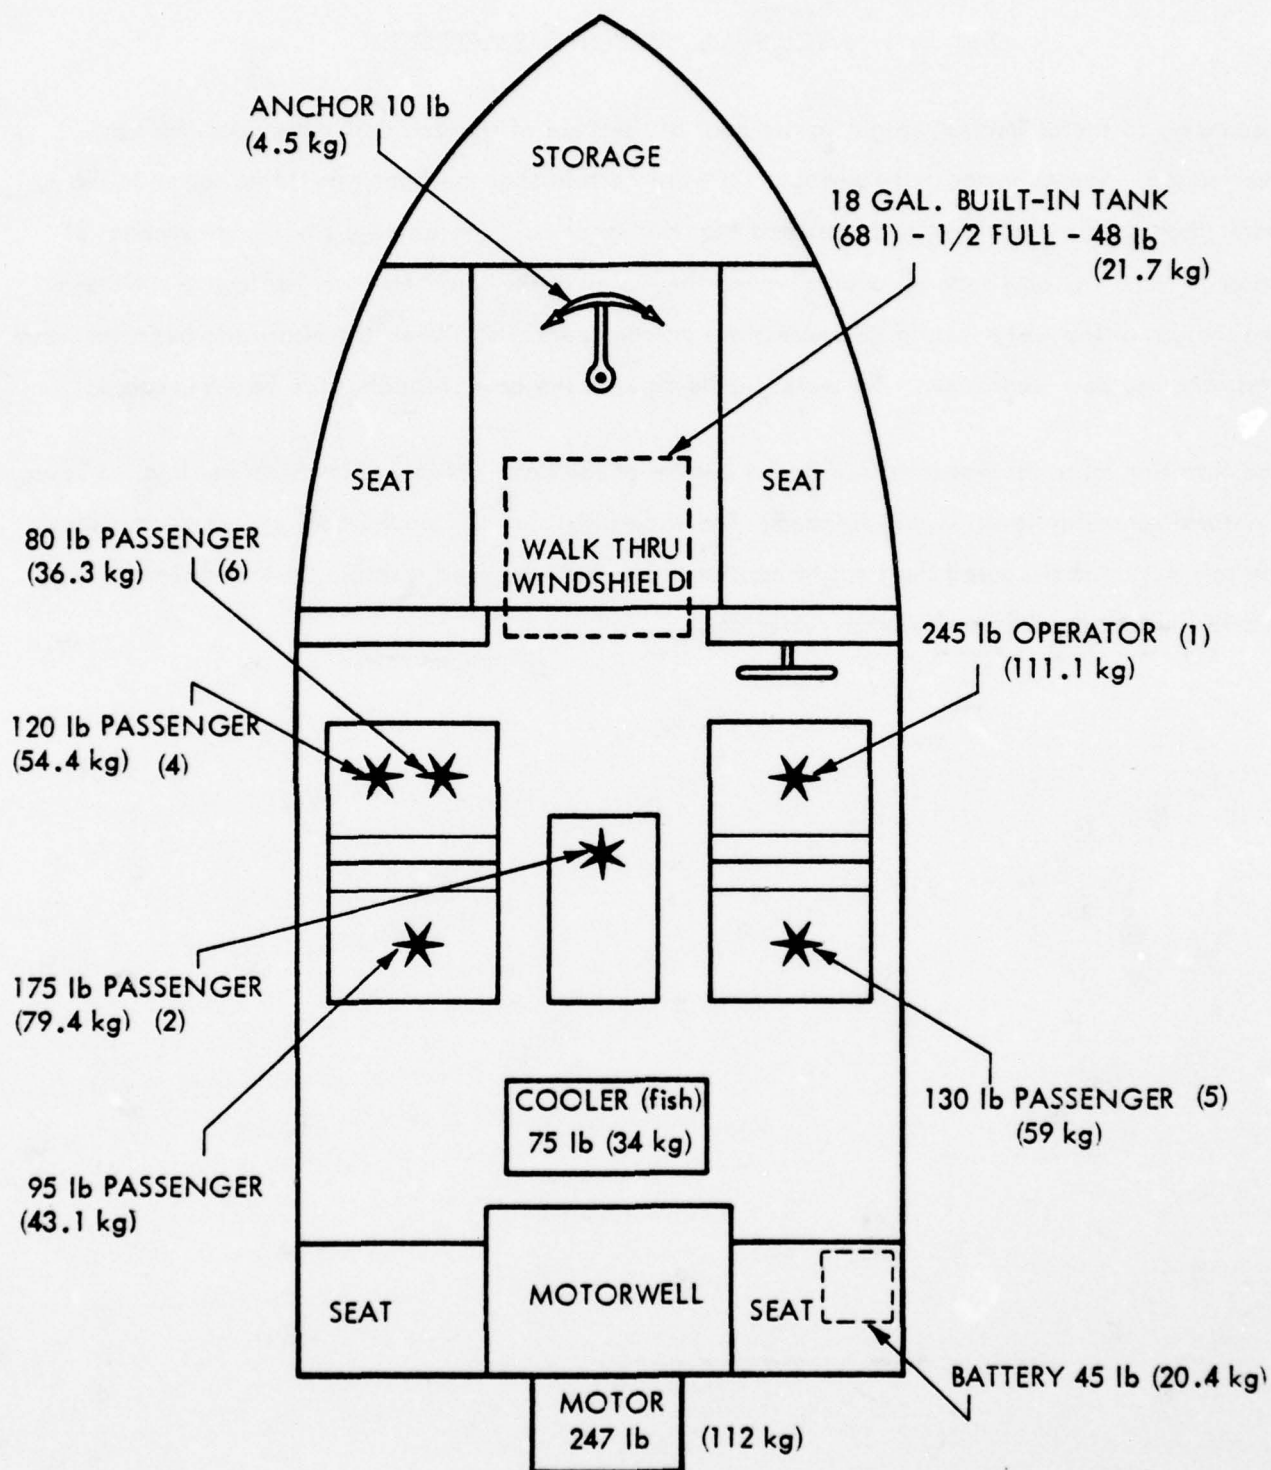
FIGURE 1. BOAT LOAD DISTRIBUTION AT TIME OF ACCIDENT

The flotation material was installed in the bottom of the boat which would cause the boat to have a natural tendency to roll when flooded. The waves hitting the flooded boat broadside initiated the roll action that caused the boat to capsize. The boat assumed a stable upside-down attitude due to the location of the flotation material.

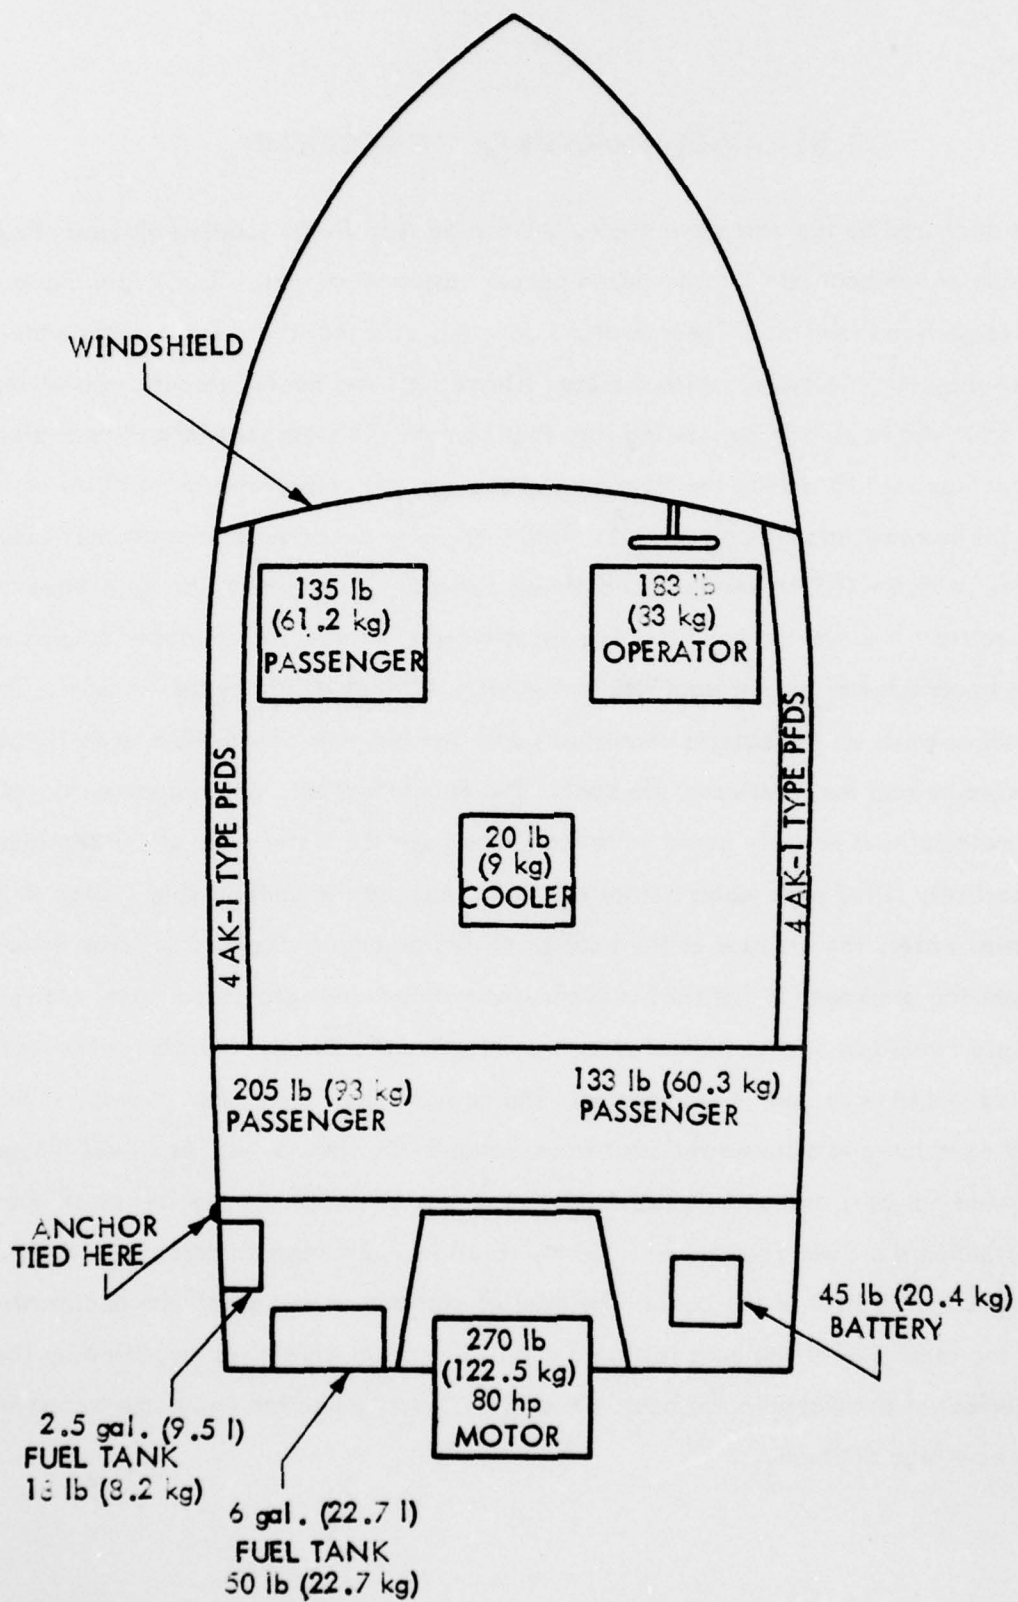
FIGURE 1. LOADING DISTRIBUTION AT TIME OF ACCIDENT

The boat was anchored by the port stern cleat. As can be seen in the loading diagram (Figure 1), the aft port side of the boat had a rather large concentration of weight. This would cause the boat to heel to port and trim aft. The operator's daughter said that there was a little water in the boat when they left the dock. With the boat trimmed aft and heeled to port, this water would also add to the heel/trim by flowing into that corner. This excess trim and heel alone might have been enough to reduce the freeboard at the port aft corner enough to allow water to flow over the transom into the motor well. The boat being anchored by the aft port cleat in two to three ft (0.6 - 0.9 m) waves would almost certainly allow water, as each wave hit the transom, to flow into the motor well. The location of the three control cable cutouts was such that the lower edge of each cutout was at the same vertical height as the transom. The absence of rubber boots on the cutouts permitted water coming over the transom to easily pass through the cutouts into the interior of the boat. The double bottom, which apparently had no flotation material and possibly could have leaked through the water sump at the transom, could have partially filled with water before the level reached the cockpit sole. Even if it did not fill with water, the attitude of the boat permitted an accumulation of a large amount of water before the passenger in the starboard aft seat noticed the water almost over her feet. If the boat were heeled to port as indicated by the weight distribution, then the water level at the port side would have been even greater. The accident may have been avoided if the engine would have run and allowed the boat to be headed into the waves. As it was though, the engine would not run, and bailing operations could not keep up with the inflow of water. By this time freeboard aft was reduced sufficiently to allow each wave to break over the transom and into the interior of the boat. The heeling moment caused by all the occupants exiting from the same side of the boat initiated a rolling motion which was amplified by the free surface effect of the water in the boat, causing the boat to capsize and come to rest in an inverted, bow high attitude.

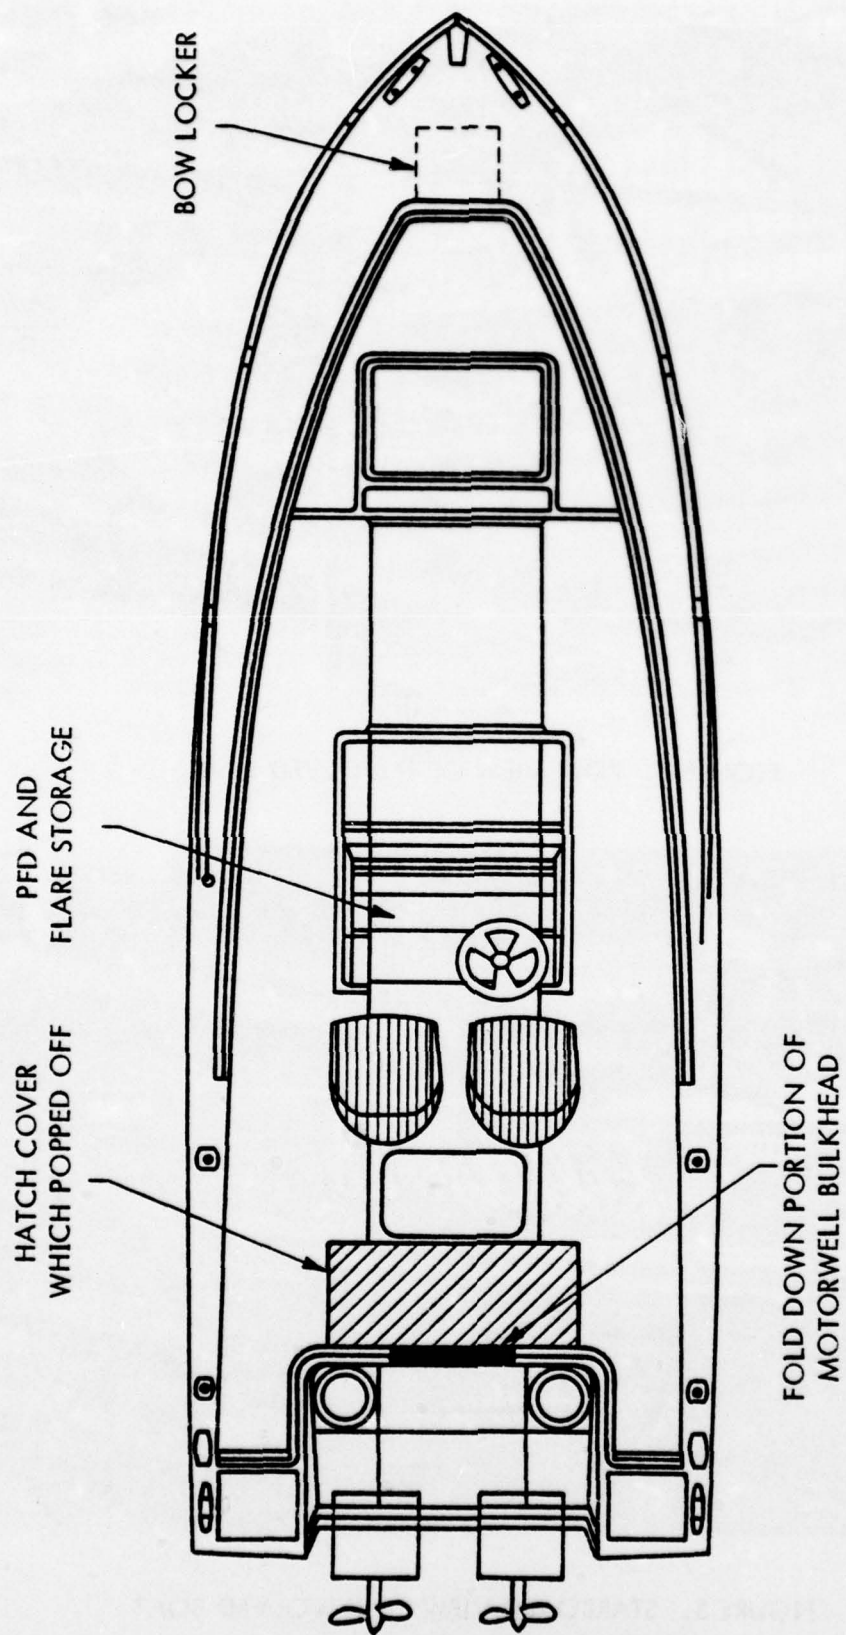
FIGURE 1. SCHEMATIC OF INVOLVED BOAT

The eventual capsizing was probably hastened by the occupants standing and rapidly moving around the boat to improve the trim and obtain gear. Their actions following the capsizing, especially involving the lifeline and not leaving the floating boat, greatly improved their chances of survival.
